SPECIAL MEETING
APALACHICOLA CITY COMMISSION
WEDNESDAY, MAY 18, 2022 – 4:00PM
BATTERY PARK COMMUNITY CENTER
1 BAY AVE., APALACHICOLA, FLORIDA 32320

**City of Apalachicola
Rehabilitation of the Middlebrook
Cotton Exchange & Warehouse**

Existing Conditions Assessment

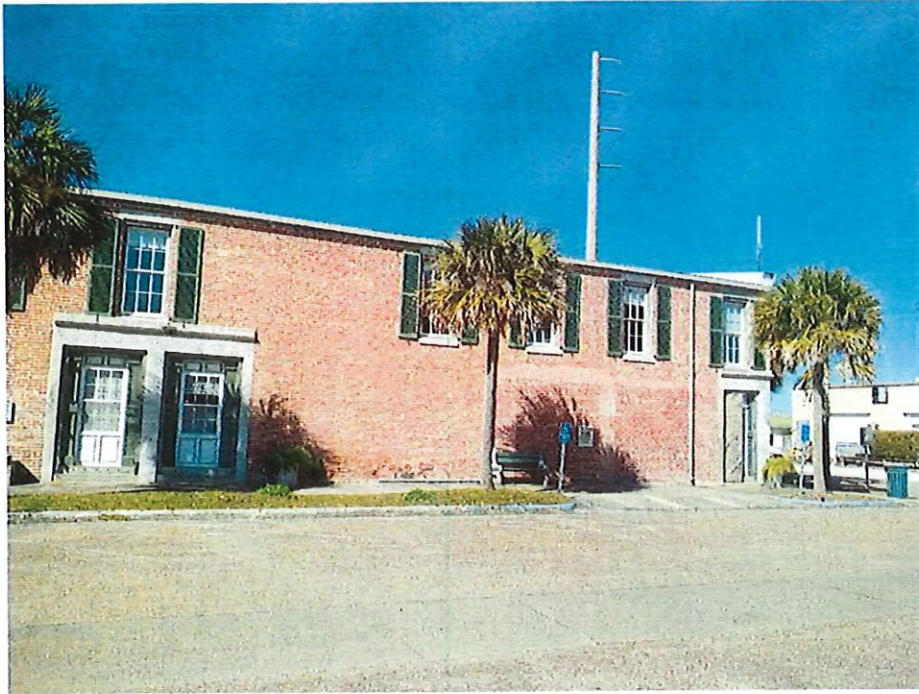
***East Elevation of Middlebrook Cotton Warehouse/Exchange – 1 Avenue "E"
Note granite lintels and columns at fenestration. It appears a series of lintels
and openings have been removed near the north end of the building.***

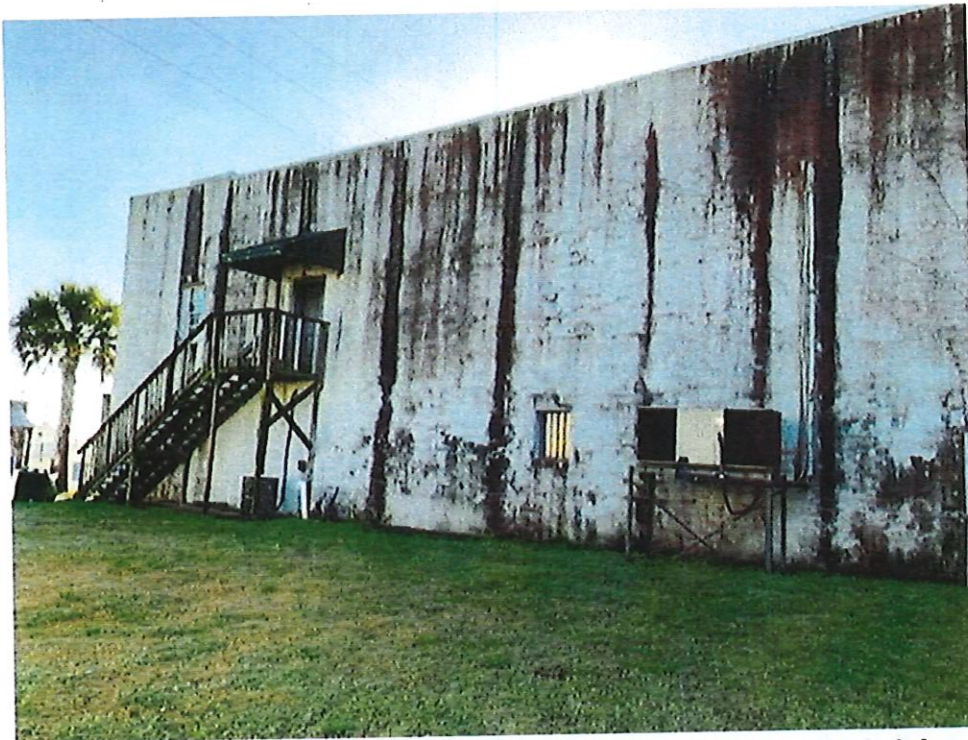
Western Elevation-Middlebrook Cotton Warehouse. The brick masonry on this elevation has been stuccoed over to preserve its integrity. The Middlebrook Building has single pitch of roof, suggesting it may have been a wider structure in its original configuration.

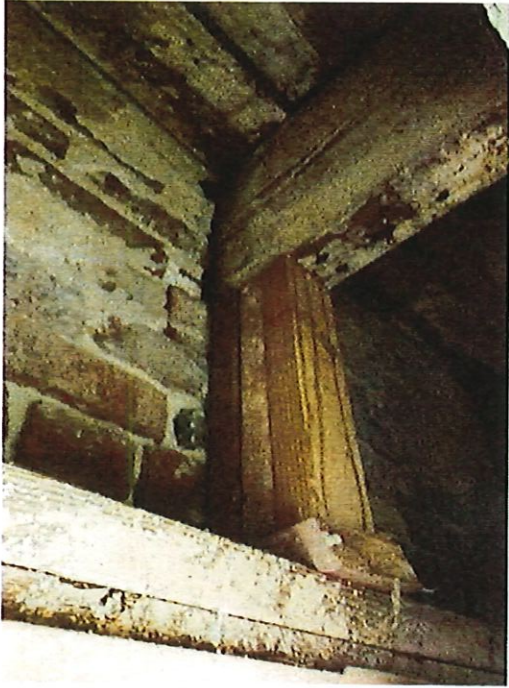
Wood 4x4 shim above wood top plate supporting deteriorated 2nd floor wooden beam

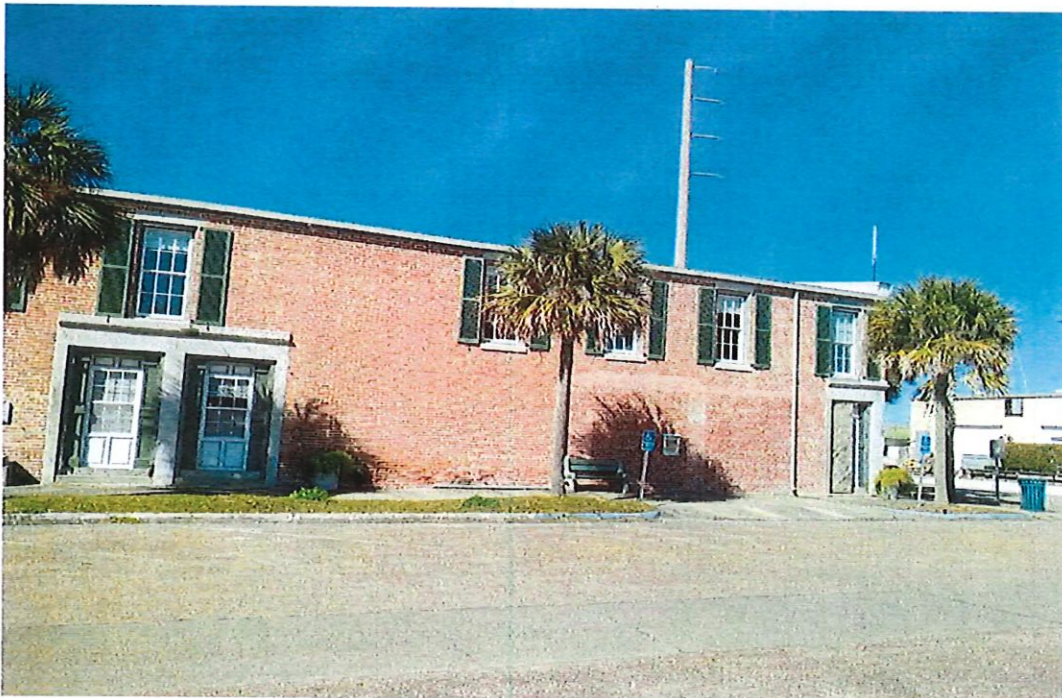
1st floor windows require replacing. 2nd floor windows to be refinished

The first floor exterior work will include replacement of six (6) non-historic first floor windows and two (2) non-historic first floor doors and one (1) non-historic second floor exterior door. Ten (10) historically proportioned second floor windows are to remain and will be recommended for reconditioning to working operational order and reglazing where necessary including refinishing and repainting.

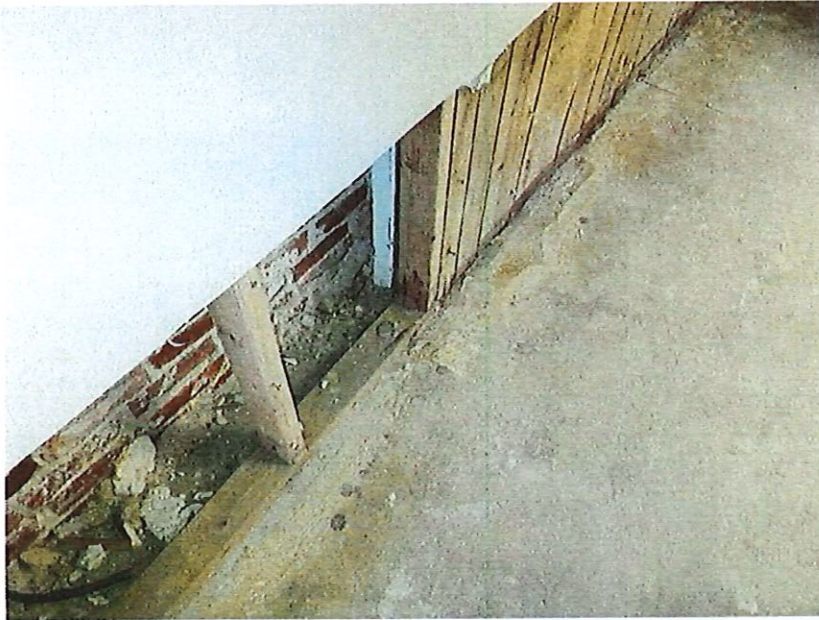
Common Wood Stud with gypsum drywall finish cut back due to flooding from Hurricane Michael' 10-10-2018. Note: Saturated insulation has been removed. Mold spores are present at floor level and wood rot is indicated at the wall sill plates despite being built with pressure treated wood material.

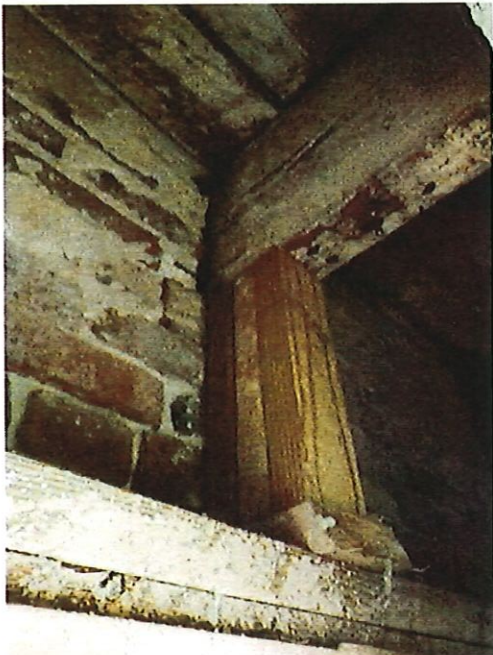
Wood 4x4 shim above wood top plate supporting deteriorated 2nd floor wooden beam

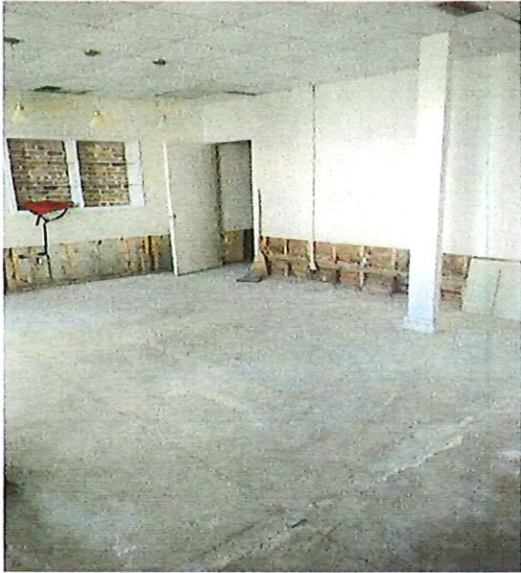
Photo shows depth of false perimeter wall supporting 2nd floor structure. Note lower 27" of gypsum and insulation has been removed due to flood damage

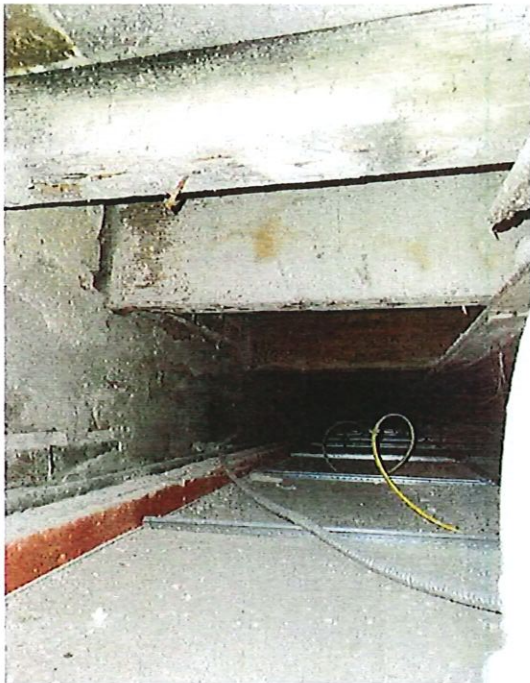
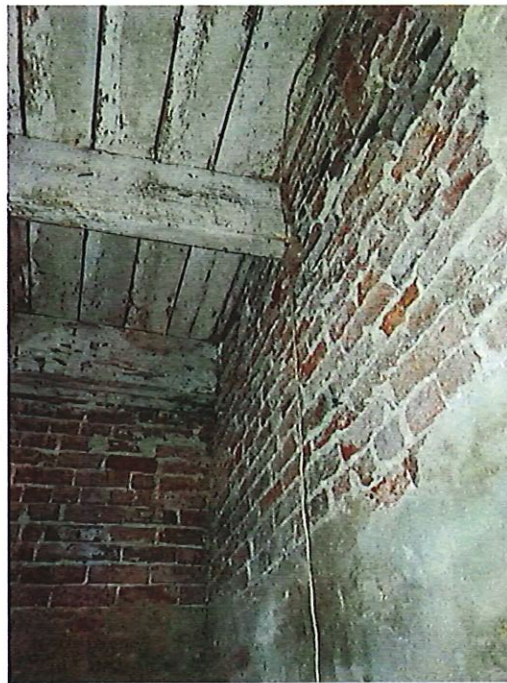
**Original 2nd floor frame in north end Middlebrook Building.
Note: Morticed and tendon constriction on brick wall with wide plank sub-floor.**

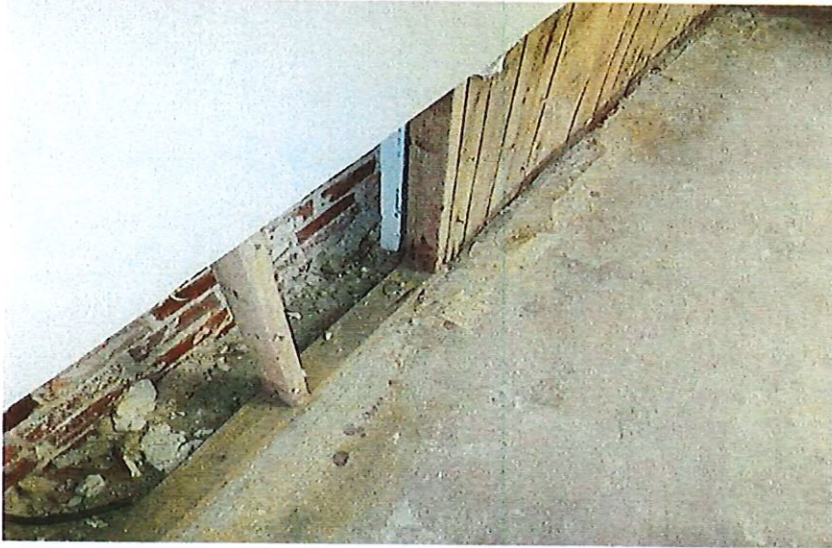
The lower sill or bottom plate of all of the interior first floor stud walls demonstrate deterioration and decay due to flooding from Hurricane Michael and other flood events which have effected to Water Street Corridor in Apalachicola.

***Sill Plates of interior walls of Middlebrook Building
flood damaged, gypsum and insulation has been removed***

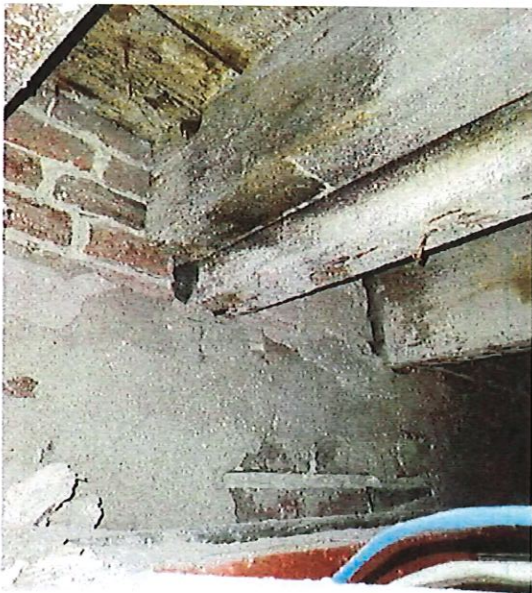
***Existing condition of historic beams at
exterior masonry wall with added
parallel beams and stucco patching***

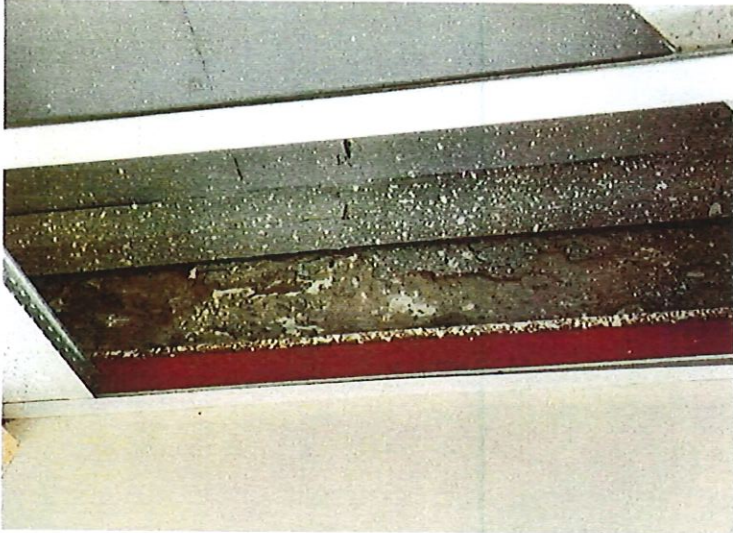
Previous steel supporting frame in Middlebrook Building. Note Fireproofing in the form of double layers of gypsum Board required by building code, located below historic wood timber frame. The added weight of these elements contribute to the sagging floor frame condition.
