SPECIAL MEETING  
APALACHICOLA CITY COMMISSION  
TUESDAY, MAY 31, 2022 – 5:00PM  
BATTERY PARK COMMUNITY CENTER  
1 BAY AVE., APALACHICOLA, FLORIDA 32320

**City of Apalachicola Harrison-Raney  
Cotton Factor & Exchange Building**

1. Project Scope and Overview
2. Abbreviated History of the City and the Subject Buildings
3. Existing Conditions Assessment Report
4. Renovation/Rehabilitation Recommendations
5. Existing Floor Plans and Elevations
6. Conclusion

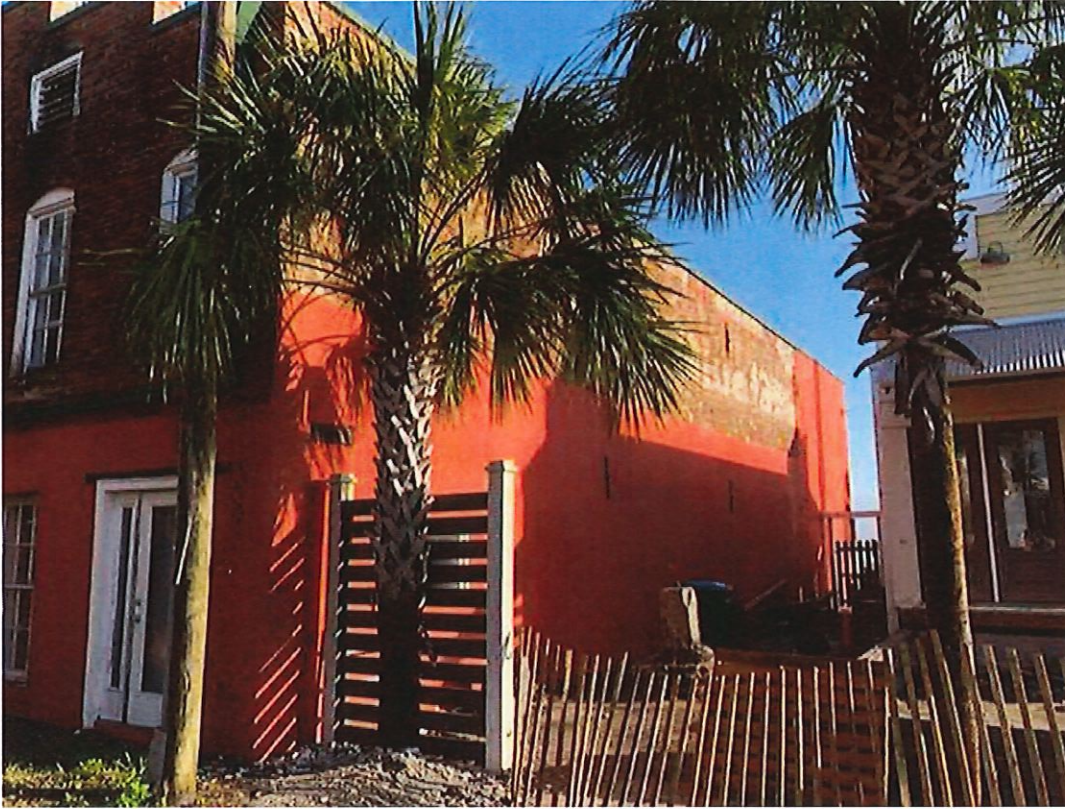
***Side and rear elevation Harrison-Raney Cotton Factor & Exchange, located at 86 Water Street, Apalachicola, Florida***

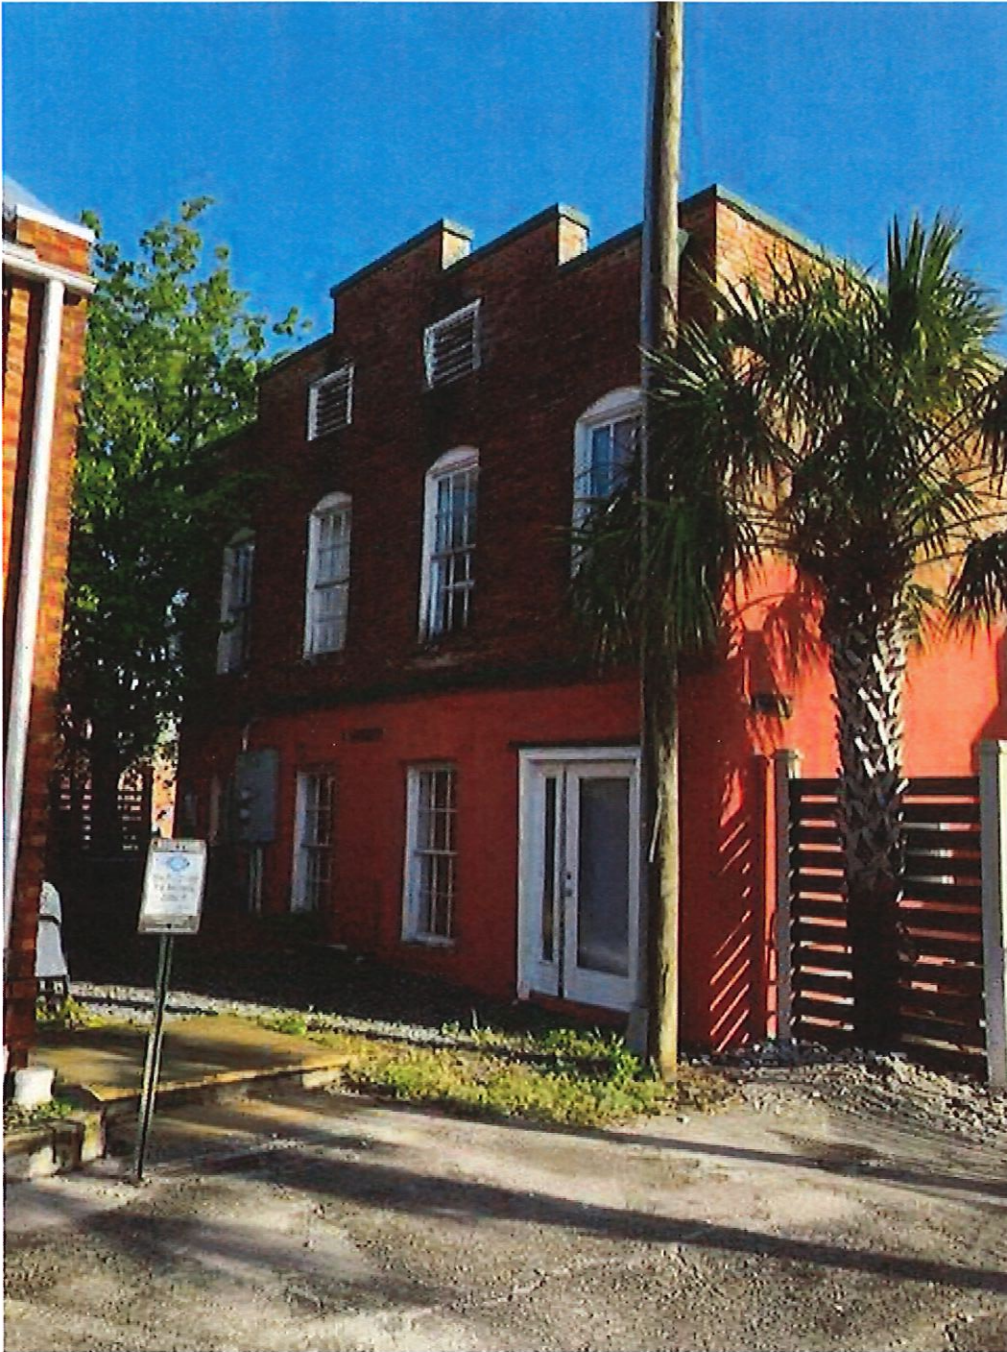
***Rear Elevation Harrison-Raney Cotton Factor & Exchange Building 86 Water Street, Apalachicola, Florida***

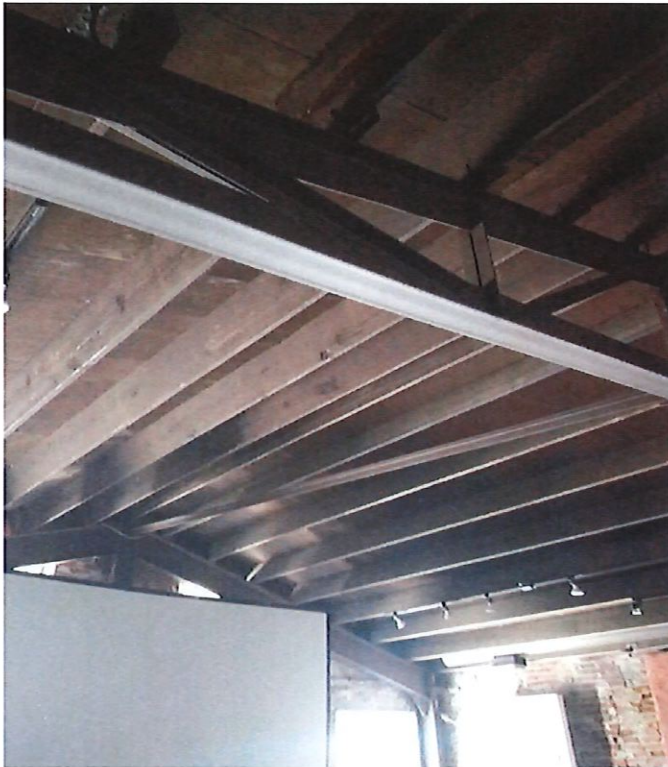
Since the strategic removal of these original wooden floor framing members, the steel frame accomplishes a variety of purposes. These include supporting the second floor and roof structure as well as providing for needed lateral support by including an interior and exterior steel plate at each column location that behave in the same manner as tie rods by clamping the exterior walls together between two plates and bolting them to the added columns.

***Second Floor Steel trusses and 2x 16 wood rafters as a "Memory" or historic reference of the former wood framed roof support system***

The vertical columns are designed to support the second floor, roof and span the entire former warehouse floor space hereby creating an interior "rigid frame" which resists deflection and sagging caused by gravity, or exterior impacts including violent weather conditions. All interior brick masonry will be repointed, and a transparent waterproofing compound applied to diminish leaking and seepage in flood conditions. The exterior work will include the potential replacement of two (2) non-historic first floor French doors located at either end of the first floor facade.

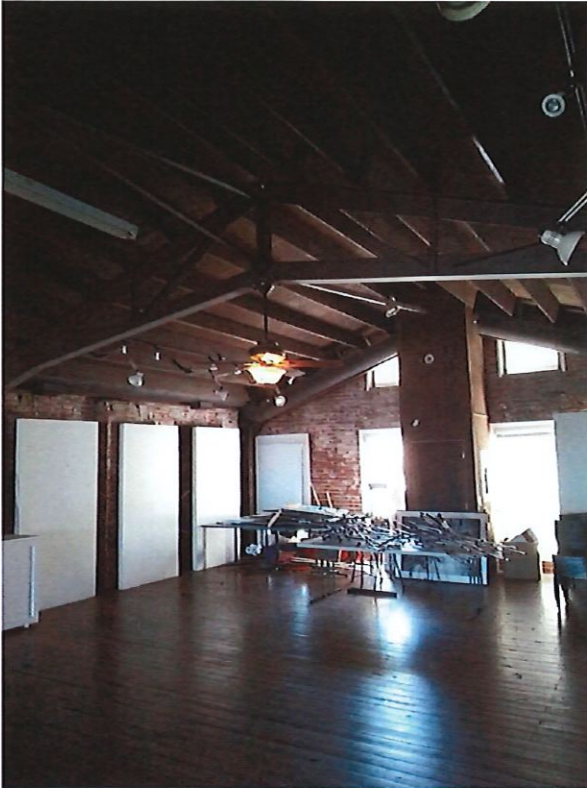
Most of the character defining historic building fabric remains intact with the exception of the then non-salvageable second floor and roof timber framing. The original second floor and roof have been demolished and rebuilt utilizing more modern materials in a manner consistent with and representational of the original historic materials.

*2<sup>nd</sup> floor of Harrison-Raney Exchange adaptively reused as local center for character History, Culture and Arts*

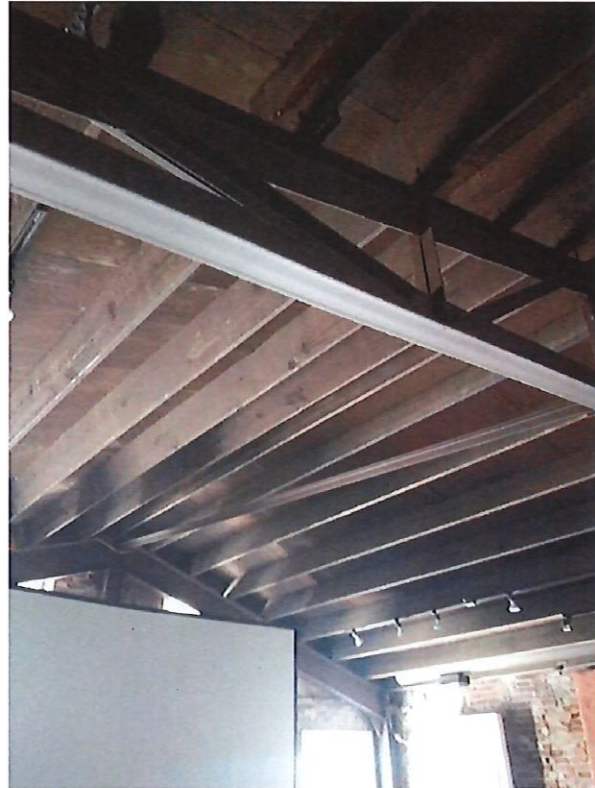
*Steel trusses and lumber roof frame provide appropriate historical*

The original second floor wood framing has been replaced by a series of welded steel columns and beams which support a wooden framed second floor and roof frame above steel spanning girders and steel trusses. These new interior steel members also provide lateral stabilizing plates and through-wall bolts welded to the interior vertical columns to support the historic exterior masonry wall structure. This system provides more than adequate structural capacity to carry the live and dead loads required for various community events, exhibits and meetings. This also provides for internal circulation via a new stairway from the first floor to second floor. The first floor provides excellent open space allowing for appropriate curation of the historical artifacts and other spaces for art and cultural exhibits. The stair for the HCA building is located within its interior while the access stair for the Middlebrook building is a wooden stairway located on the west side exterior of the building. It is not accessible from the interior first floor. The four double French style doors of the Harrison-Raney Building present an inherent weakness to storm resiliency and weather resistance. Historic photographs suggest that these are not historically accurate and could be redesigned to add some higher level of storm resistance based on minor reconfiguration of the entry sequence.

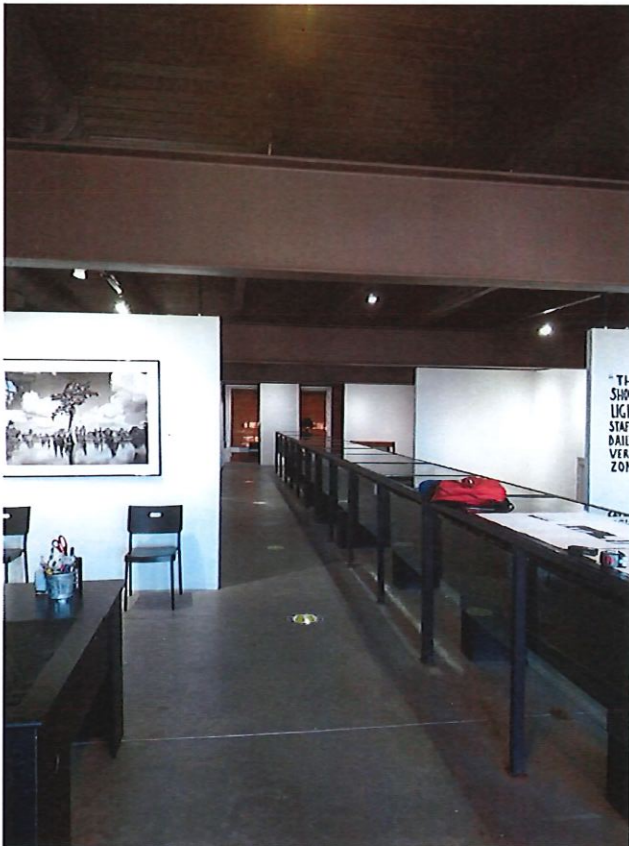
**Renovated Harrison-Raney Cotton Factor & Exchange.  
Currently the Apalachicola Center for history, Culture and Art.**

The 1992-1994 renovation of the Harrison–Raney building provided for both interior and exterior brick repointing and any sign of previous storm damage has been cleaned, repaired and/or renovated and repainted. No exterior windows face on the Avenue “E” elevation, preventing damaging flood waters. No opening exist with the exception of the front and rear facades, the rear elevation eighty feet farther south. The only public points of entry that exist are the four pairs of six foot wide, seven feet tall French doors that open to the Water Street elevation. Storm mitigation proposals for the river front elevation will be proposed, however, recent storm surge and sea level rise projections indicate that the probable water crest projections will exceed the allowable height limitations of most currently available storm protection technology.

As previously noted, the Harrison-Raney Cotton Exchange Building requires only repointing of both the interior and exterior brick masonry walls and the recommended coating of a transparent waterproofing sealant application to the interior and exterior masonry. It may require some relocation of existing electrical systems in the form of switching and outlet locations and consideration of adding a more substantial and robust form of storm resistance protection, particularly along the Water Street exposure.

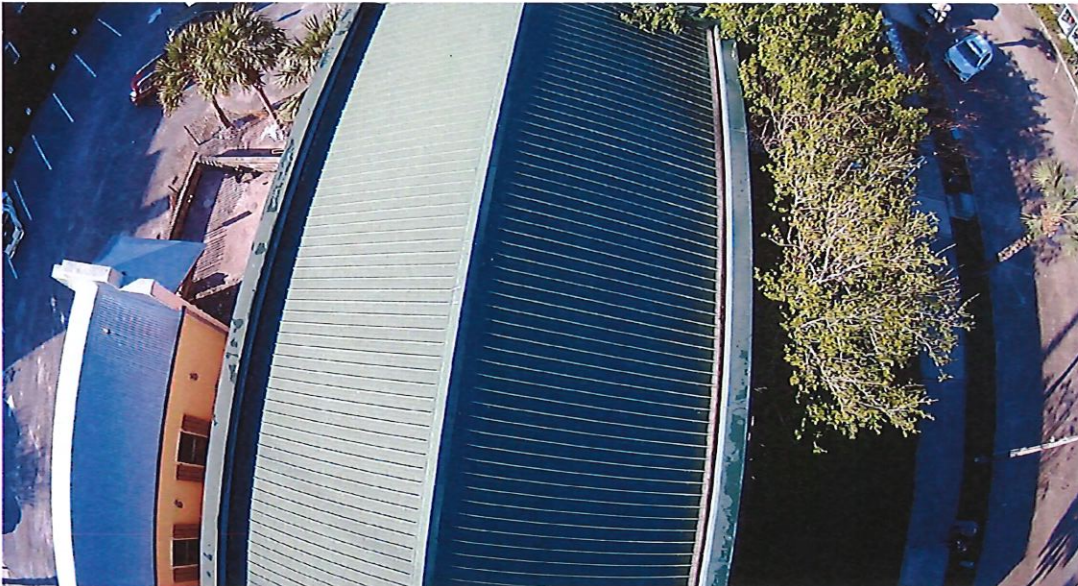
Upon inspection, neither building appear to require re-roofing. The documented date of the last reroofing for the Harrison-Raney building is unknown to the investigators.

***Roof surface of Harrison-Raney building, 86 Water Street Apalachicola, Florida***

The roof surface of the Harrison-Raney Building has been re-roofed with a pale blue, standing seamed metal roof of dense aluminum with a concealed spline and fastener system. This roof material and fastening system is considered to be superior for hurricane and weather resistance. The pitch is low at approximately 3/12-4 /12. The metal surface of the Harrison Raney building also provides significant fire protection for buildings and fire resistance. This fairly common coastal roofing installation provides for a durable and long lasting roof surface with no exposed fasteners which might corrode or become loose due to high winds. While not consistent with historical photographs that indicate that the roofing for nearly all of the completed Water Street cotton Warehouses and Exchanges were originally wooden shakes, this metal roof provides a low maintenance and a 50 year wearing surface. The roof is hidden behind a crenulated parapet and barely visible from the street level on any elevation.
