Achieving Resilience through Hazard Mitigation

Applying Mitigation Measures to Apalachicola's Vulnerable Historic and Economically Significant Resources

APALACHICOLA, FLORIDA Nonstructural Flood Mitigation Assessment

February 2020

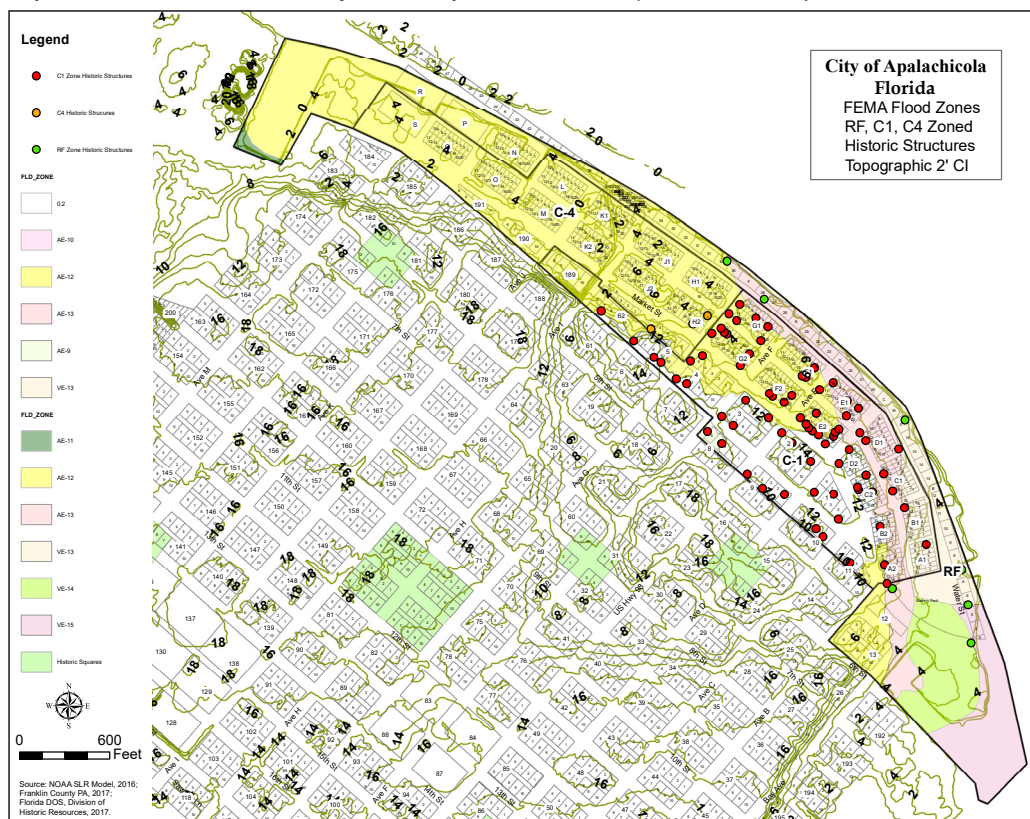
Map 14. Historic Resources in the City's Area of Special Flood Hazard (Rated A & V zones)

The City's 2017 Vulnerability Analysis identified historic structures located within the FEMA flood zones. Many of those buildings are commercially important businesses within the downtown historic commercial district.

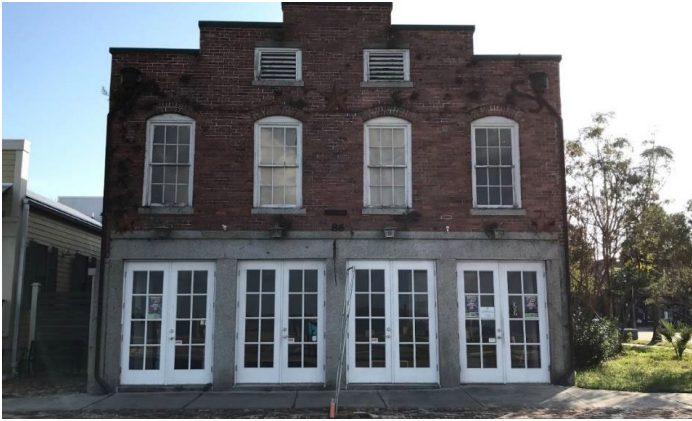
Apalachicola Center for History, Culture and Art.
86 Water Street. MSF FR00339.

The HCA building is located in FEMA's Area of Special Flood Hazard Zone AE13 which requires a Base Flood Elevation (BFE) of 14 feet. As surveyed, the first floor elevation is 6.5 feet, rendering the building 6.5 feet below the minimum flood mitigation elevation requirements for that respective flood zone.

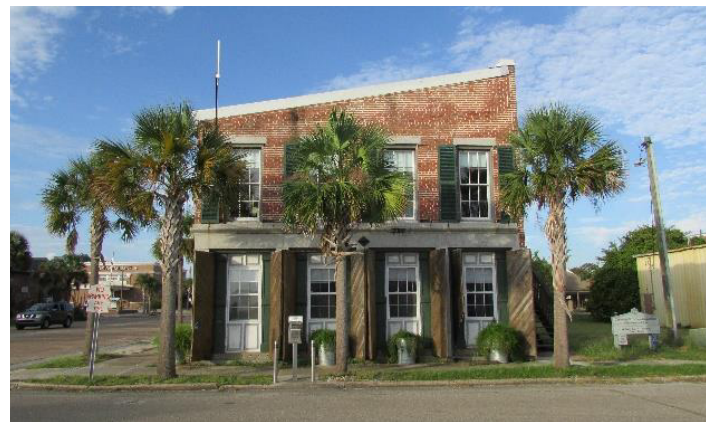
Old City Hall
1 Avenue E. MSF FR00344.

The former City Hall building is located in FEMA’s Area of Special Flood Hazard Zone AE13 which requires a Base Flood Elevation (BFE) of 14 feet. As surveyed, the first floor elevation is 6.4 feet, rendering the building 7.4 feet below the minimum flood mitigation elevation requirements for that respective flood zone.

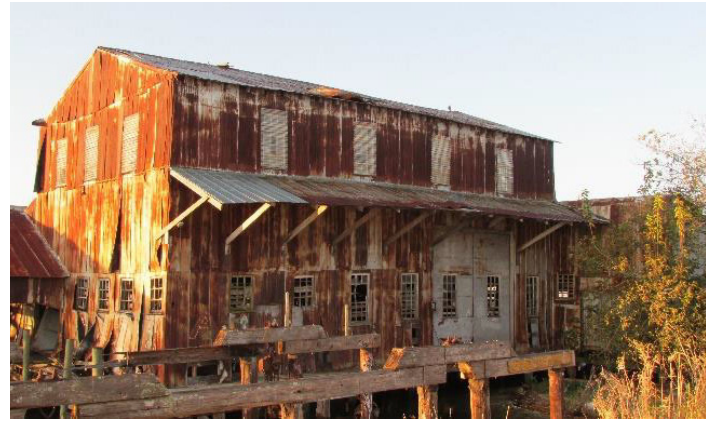
Popham Building
Water Street, Wharf Lot 7-8. MSF FR00288

The Popham building is a two-story 61,000 square foot metal warehouse building located on and over the Apalachicola River at the south end of Water Street. Built in 1923 by 19th century entrepreneur William Lee Popham, the building was intended to be an oyster production factory to process, can and warehouse a promised glut of oysters that Popham envisioned coming as the result of a land scheme he launched that included an oyster lease as part of a land purchase deal. At one time, the words “POPHAM OYSTER FACTORY NO. 1” were spelled out in oyster shells on the front of the building. The wooden building covered with metal siding was built on pilings that extended out over the water. The two-story central section of the building was distinguished by four gabled bays.

The Popham Building is located in the FEMA Velocity VE-13 flood zone. Flood mitigation for the lowest flood risk and lowest flood insurance rates will require the lowest structural member be at 14 feet.

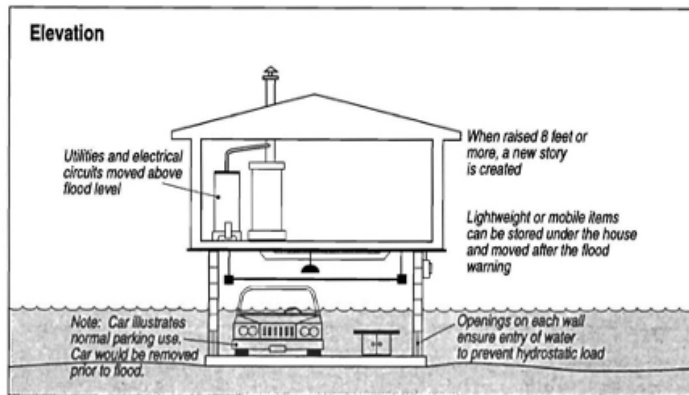
Figure 1 Elevation of Building

Elevation of Building. This measure requires lifting the entire building or the habitable area to above a specific flood elevation, as shown in Figure 1. Elevation of the building will require addition to or replacement of the original foundation. All utilities for the building must be located at or above the required elevation. Access for the disabled will need to be addressed with this type of project.

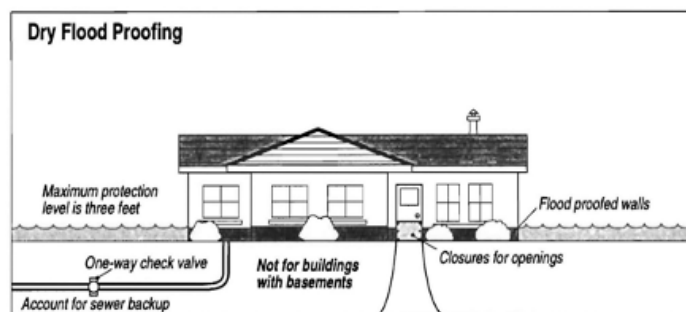
Figure 2 Dry Flood Proofing a Building

This measure consists of waterproofing the exterior of the at-risk building to prevent the penetration of flood waters. This measure is generally acceptable with commercial buildings, but will require certification from a licensed engineer or architect. Based upon previous testing by the US Army Corps of Engineers during the 1970's, a "conventionally" constructed wooden exterior building can be dry flood proofed up to 3-feet on the exterior walls. This would be appropriate for the older building stock located throughout Apalachicola, where wood was a common exterior construction material. Due to improvements in building construction methodology (fasteners, strapping, materials,

etc.) dry flood proofing may be acceptable up to 4-foot of height. Exterior materials such as reinforced concrete and reinforced masonry may support flood loads in excess of 4-feet. A structural analysis of the wall strength is required if the flood proofing system is proposed for a higher level of protection. A sump pump with independent power supply (battery backup) in case the utility company power is lost is required to remove any flood waters that seep into the building during the event. Closure panels are required for all openings. Figure 2 illustrates a building with dry flood proofing.

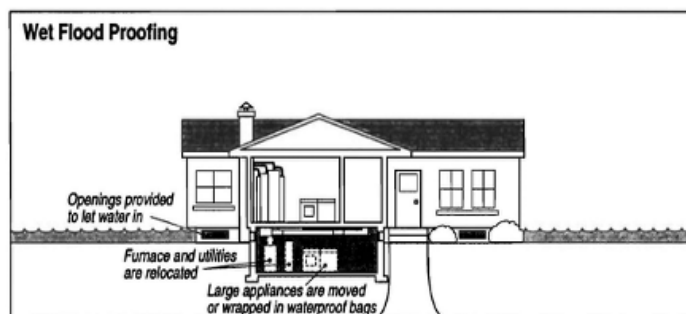
Figure 3 Building with Wet Flood Proofing

This measure is applicable as either a stand-alone measure or as a measure combined with other nonstructural measures such as elevation and dry flood proofing. As a stand-alone measure, all construction materials and finishing materials to a specific height are required to be water resistant. An example is shown in Figure 3. All utilities must be elevated above the design flood elevation. Wet flood proofing is applicable to commercial and industrial buildings and should be considered for combining with a flood warning system, flood preparedness and flood response plan. This measure is generally not applicable to deep flood depths and high velocity flows due to possible failure of structural walls.

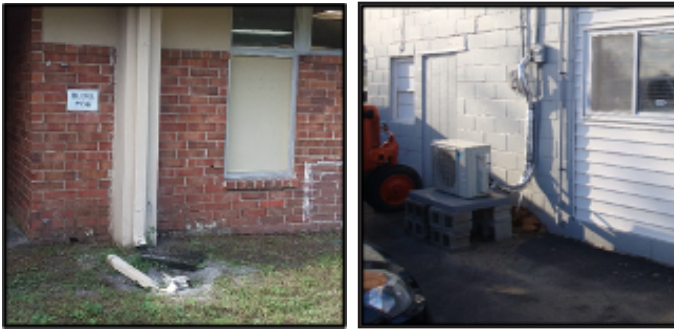
Localized Interior Drainage and Utilities

concerns which can adversely impact a building. Many of the downspouts discharging rooftop runoff (photograph on left) were not properly directing water away from the foundation, causing erosion, and thereby exposing and weakening the foundation and providing potential pathways for floodwaters to enter or further damage some structures. Similarly, the external HVAC system is susceptible to flooding if not properly elevated.

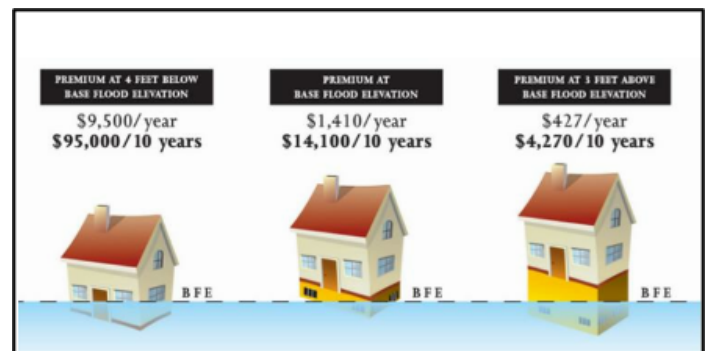
Residential Actuarial Flood Insurance Premiums

Flood insurance is moving toward actuarial rates and the benefit of elevating a residential building to above the flood risk will not only result in lower premiums, but will also result in lower flood damages for the frequent flood events.

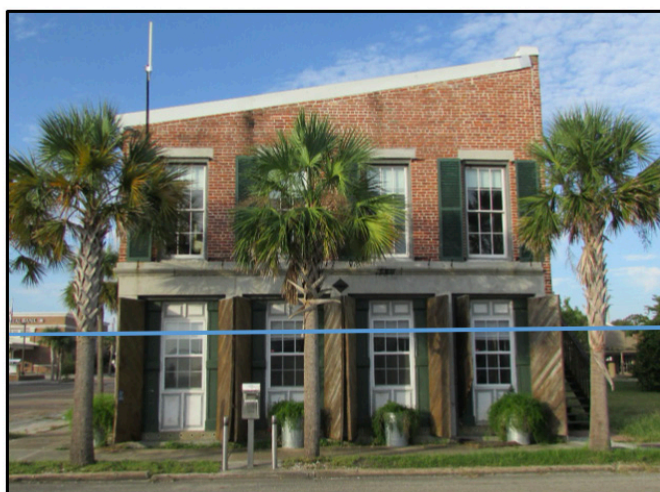
Proposed flood hazard mitigation project: The method of flood hazard mitigation selected for this building is to elevate the building. This type of flood mitigation project will reduce flood risk and flood insurance premiums when the project is completed.

Cotton Warehouse/City Hall building with BFE Illustrated

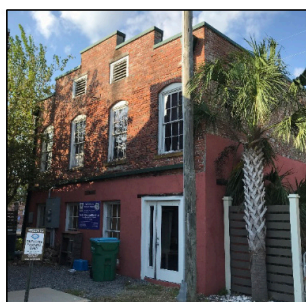
Rear View

The Apalachicola Center for History, Culture & Art (1840 circa) is one of two surviving cotton warehouses that once lined the docks of Apalachicola in the decades prior to the Civil War. The building is constructed of older historic bricks, creating a thick wall building on the ground floor. This building is 7.4 feet below the minimum flood mitigation elevation requirement, including the locally required 1-foot free board. The building needs some maintenance to the brick construction, called repointing, which refers to the mortar joint replacement common to this era construction. The interior bricks are exposed which facilitates this important maintenance activity. Re-pointing of the mortar joints will enhance the building wall strength and resistance to water penetration.

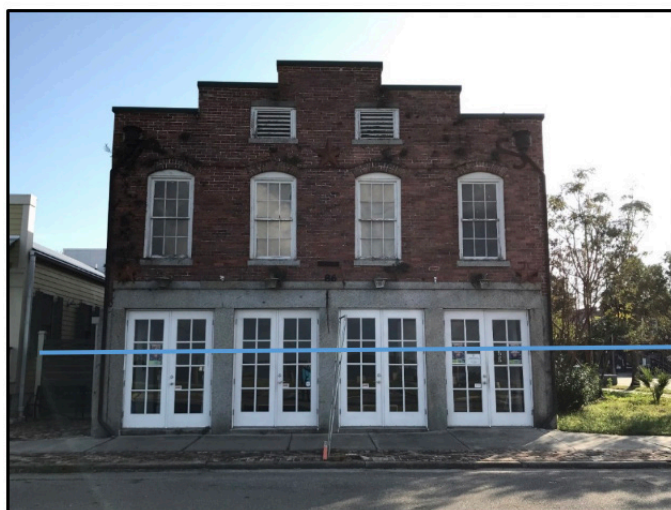
Structure Information/Data			
Structure Identifier Number	FR00339	Ceiling height (feet)	9
Occupancy type	Commercial	Freeboard (feet)	1
Number of Structural Corners	4	First Floor Elevation (FF) (feet)	6.5
Number of Stories	2	Lowest Adjacent Grade (LAG) (feet)	6
Building Construction Matl	Brick	Basement/Crawlspace Elevation	n/a
Foundation Material	Brick	Max 1% Flood Velocity	Stillwater
Slab/Crawlspace/Basement	Slab	Base Flood Elevation (BFE)	AE-13
Condition (Good/Fair/Poor)	Good to fair	FF minus BFE (feet)	-6.5
1st Floor Window Count	0	FF minus LAG (feet)	0.5
1st Floor Pedestrian Door Count	4 double	Flood Depth (BFE-LAG) (feet)	7
1st Floor Vehicle Door Count	0	Perimeter Distance (feet)	220

HCA Warehouse building with BFE Illustrated

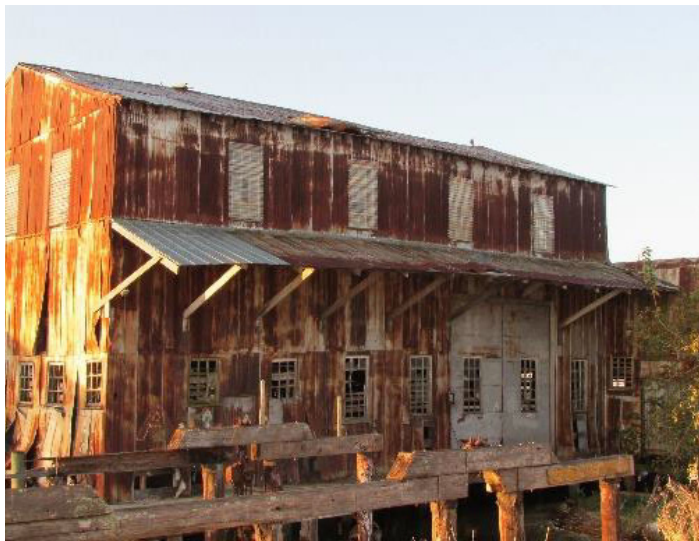
**Popham/Apalachicola Boatworks
Water St, Apalachicola, FL**

The Popham building is a wood frame constructed building located on Water Street next to the Hwy 98 bridge over the Apalachicola River. The building was constructed in 1923 as an oyster processing and packing facility. In 1948 a new owner made some major repairs and opened up the interior. The building was the major boat repair facility until closed in the early 1980's. In 2009, the State of Florida helped the City purchase the building and plans are to renovate it as the community maritime museum. The building is a contributing structure in the National Register listed Apalachicola Historic District. The building is 13-feet below BFE and has substantial damages due to Hurricane Michael. This level of flood depth and wood frame construction over water doesn't afford the opportunity to dry flood proof the building.

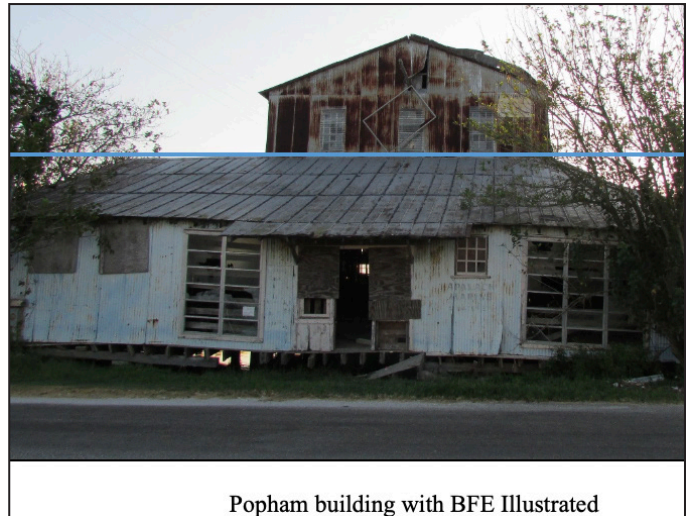
Popham building with BFE Illustrated

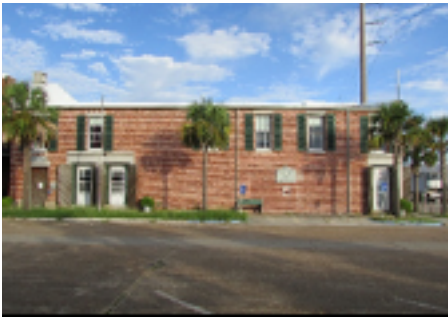
**Former City Hall
Cotton Warehouse**
1 Ave E
Apalachicola, FL

This publically-owned structure is a 150+ year-old brick grade-level warehouse. The mitigation team recommends elevation for consistency with FEMA regulations. The architectural recommendation is to install backflow valves and aluminum flood shielding on all first floor openings and external coating on masonry surfaces.

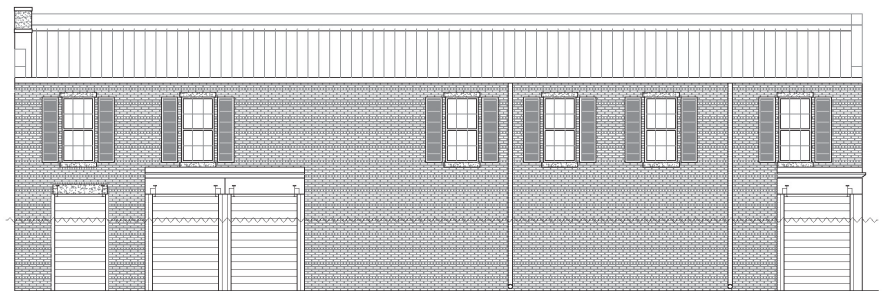
Proposed floodproofing side elevation

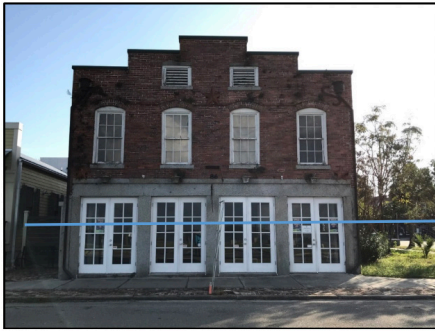
HCA Warehouse building with BFE Illustrated

This publically-owned structure is a 150+ year-old brick grade-level warehouse. The mitigation team recommends elevation for consistency with FEMA regulations. The architectural team recommends implementing measures to make the existing grade-level structure flood resistant. The architectural team recommends the installation of aluminum flood panels over the first floor doors.

The flood hazard mitigation assessment of the building requires an examination of multiple variables relating to the building and the flood elevation. The high flood elevation required at this site, AE-13, restricts the possible flood hazard mitigation techniques appropriate for the building due to the finished floor elevation of 6.5-feet. The nonreinforced brick walls of the building prevent dry flood proofing of the building exterior walls due to the potential of wall collapse due to hydrostatic pressures at the 7-foot flood elevation. The flood hazard mitigation of the building will require an elevation on site project including a new foundation and pier construction enabling low value storage below the first floor. Stairs and an elevator will be required for access to the building. All utilities need to be elevated to the level of the top of the finished floor.

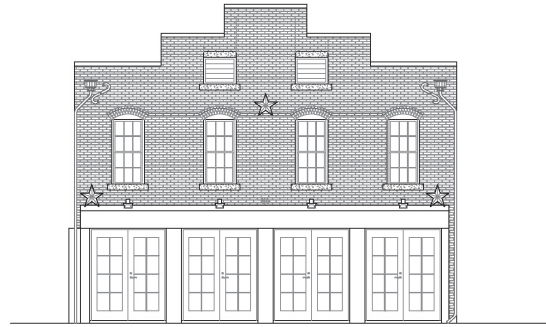
As-Built front elevation

APALACHICOLA FL. ACHIEVING RESILIENCE
THROUGH HAZARD MITIGATION
BUILDING #2 FRONT ELEVATION - AS-BUILT CONDITIONS
HCA WAREHOUSE / MUSEUM
86 WATER ST, APALACHICOLA, FL

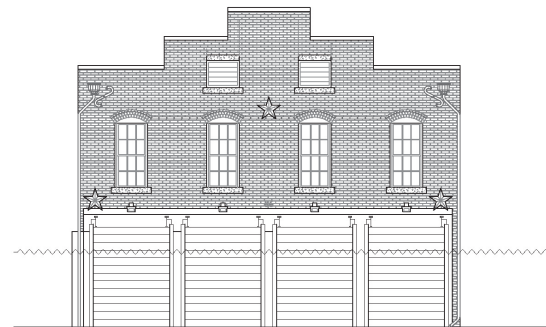
Proposed Floodproofing front elevation

APALACHICOLA FL. ACHIEVING RESILIENCE
THROUGH HAZARD MITIGATION
BUILDING #2 FRONT ELEVATION - PROPOSED FLOOD MITIGATION
HCA WAREHOUSE / MUSEUM
86 WATER ST, APALACHICOLA, FL

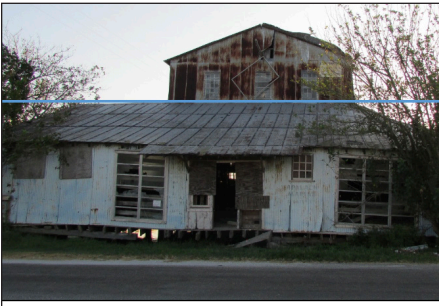
Popham building with BFE Illustrated

This publically-owned structure is a metal and wood-frame warehouse structure over the water. The mitigation team recommends elevation for consistency with FEMA regulations. The architectural team recommends wet flood-proofing to required BFE.

Proposed flood hazard mitigation project: The method of flood hazard mitigation selected for this building is to elevate the building. This type of flood mitigation project will reduce flood risk and flood insurance premiums when the project is completed. There is work required to repair hurricane damages prior to the building being elevated.

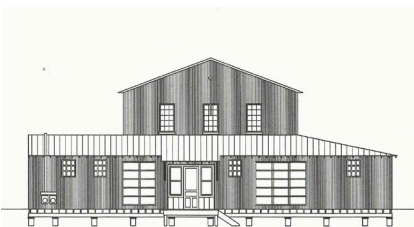
wet flood proofing methodology

Popham Marine/Boat Works

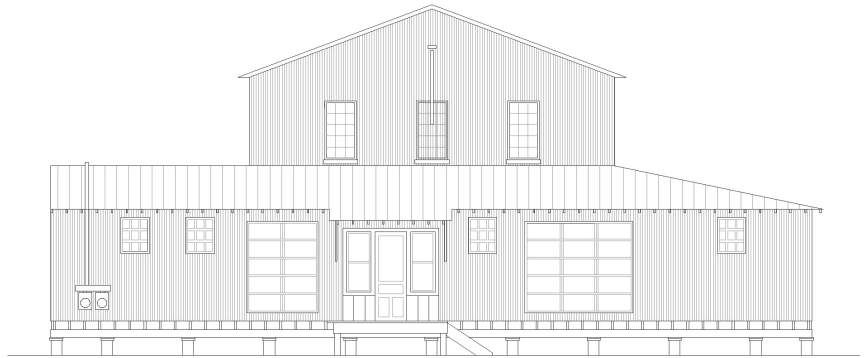
As-Built front elevation

APALACHICOLA FL. ACHIEVING RESILIENCE
THROUGH HAZARD MITIGATION
BUILDING #3 FRONT ELEVATION - AS-BUILT CONDITIONS
POPHAM / APALACHICOLA BOAT WORKS
1 BAY AVE. APALACHICOLA, FL

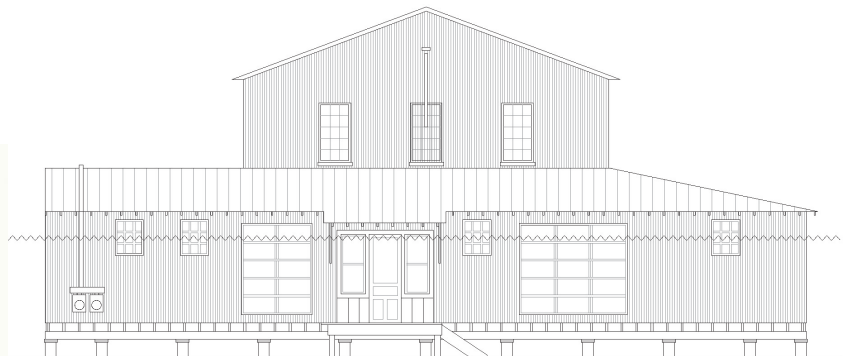
Proposed Floodproofing front elevation

APALACHICOLA FL. ACHIEVING RESILIENCE
THROUGH HAZARD MITIGATION
BUILDING #3 FRONT ELEVATION - PROPOSED FLOOD MITIGATION
POPHAM / APALACHICOLA BOAT WORKS
1 BAY AVE. APALACHICOLA, FL

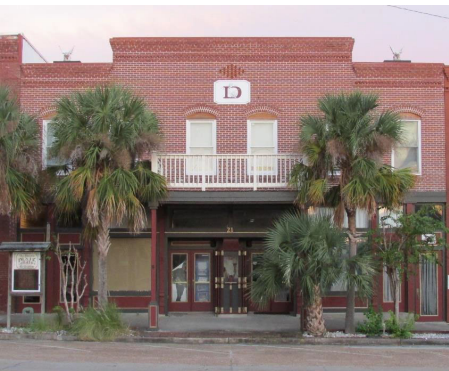
Dixie Theatre
21 Avenue E
Apalachicola, FL

This two-story 100-year+ brick structure is a grade-level building. The mitigation team recommends dry floodproofing. The architectural team’s recommendation is dry floodproof also. The recommendation from the architectural team is to install backflow valves and aluminum self-sealing flood panels on first floor and external coating on masonry surfaces.

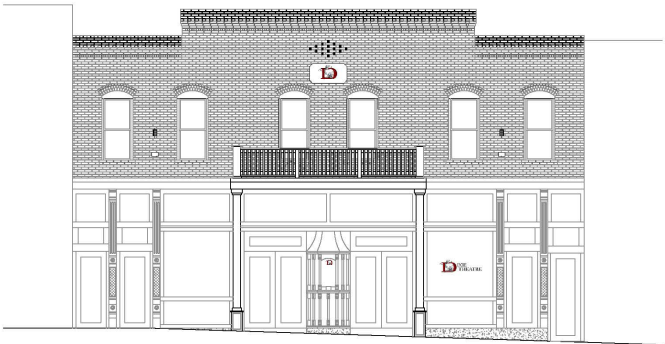
As Built front elevation

APALACHICOLA FL. ACHIEVING RESILIENCE
THROUGH HAZARD MITIGATION
BUILDING #5 FRONT ELEVATION - AS-BUILT CONDITIONS
DIXIE THEATHEAT
21 AVE E. APALACHICOLA, FL

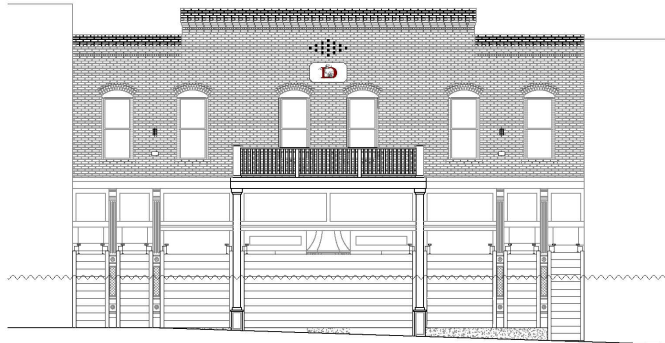
Proposed Floodproofing front elevation

APALACHICOLA FL. ACHIEVING RESILIENCE
THROUGH HAZARD MITIGATION
BUILDING #5 FRONT ELEVATION - PROPOSED FLOOD MITIGATION
DIXIE THEATHEAT
21 AVE E. APALACHICOLA, FL

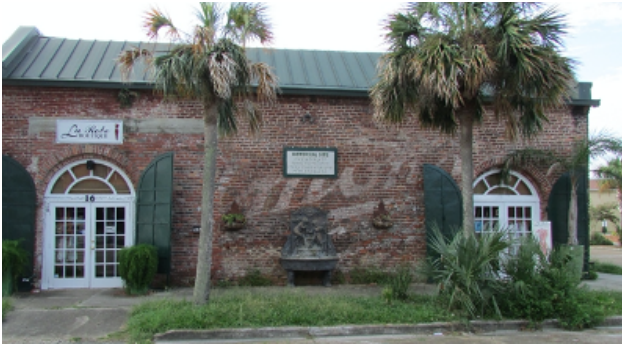
Sponge Exchange

This 100-year+ brick structure is a grade-level building. The mitigation team recommends dry floodproofing. The architectural team's recommendation is dry floodproof also. The recommendation to install flood panels.

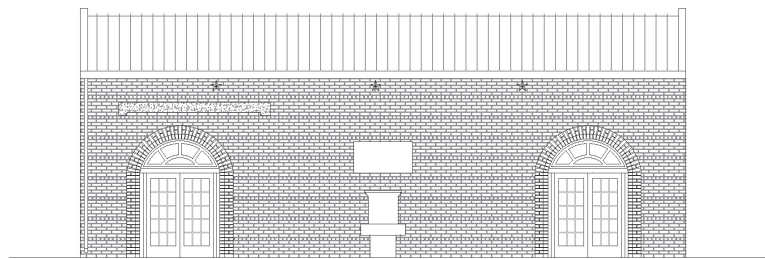
As Built front elevation

APALACHICOLA FL. ACHIEVING RESILIENCE
THROUGH HAZARD MITIGATION
BUILDING #9 FRONT ELEVATION - AS-BUILT CONDITIONS
THE SPONGE EXCHANGE
15 AVE E. APALACHICOLA, FL

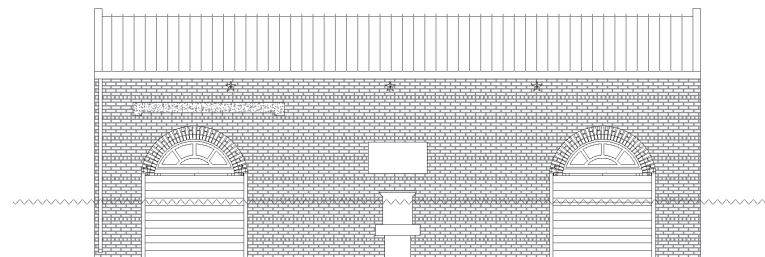
APALACHICOLA FL. ACHIEVING RESILIENCE
THROUGH HAZARD MITIGATION
BUILDING #9 FRONT ELEVATION - PROPOSED FLOOD MITIGATION
THE SPONGE EXCHANGE
15 AVE E. APALACHICOLA, FL

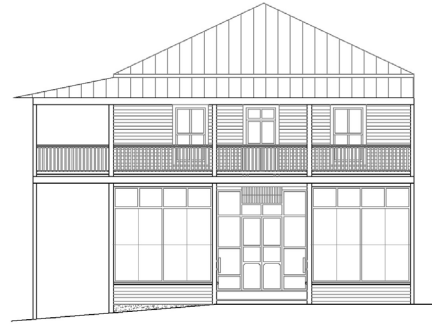
This architectural drawing shows the front elevation of a two-story house. The house features a gabled roof with a decorative bargeboard pattern. The second floor has a balcony with a railing, flanked by windows. The first floor has large windows and a central entrance. The house is built on a sloped lot, with a retaining wall and a ramp leading to the entrance.

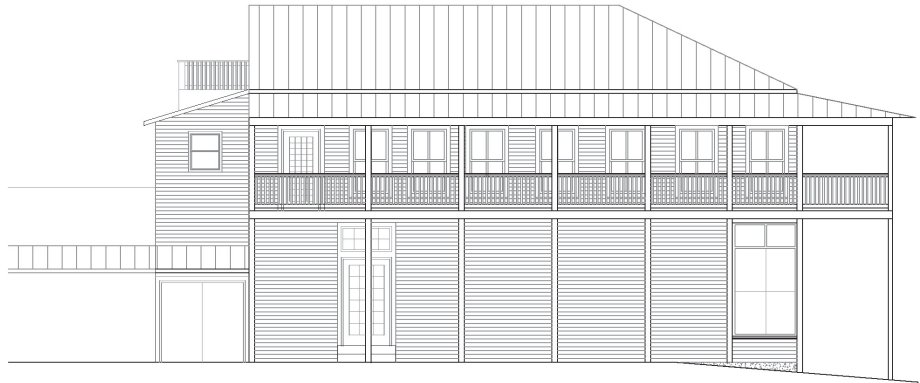
As-Built side elevation

APALACHICOLA FL. ACHIEVING RESILIENCE
THROUGH HAZARD MITIGATION
BUILDING #4 SIDE ELEVATION - AS-BUILT CONDITIONS
THE BOWERY INN
161 COMMERCE ST. APALACHICOLA, FL

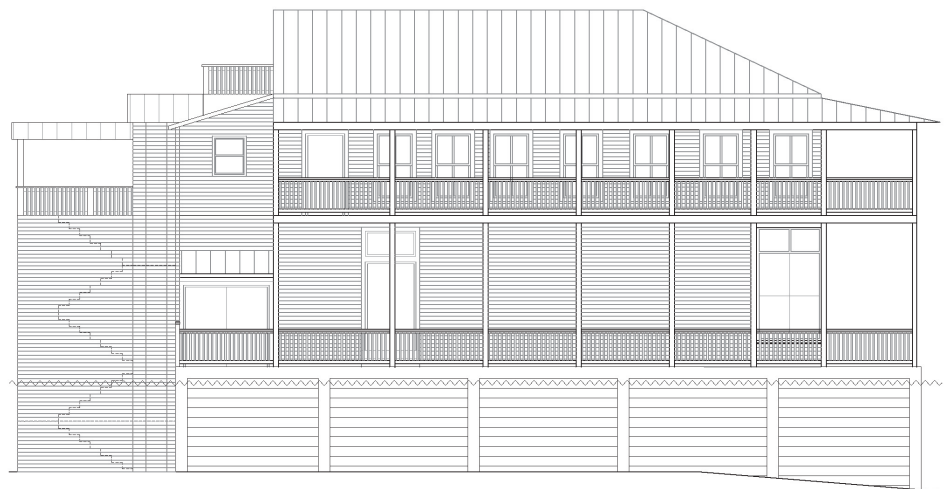
Proposed Floodproofing side elevation

APALACHICOLA FL. ACHIEVING RESILIENCE
THROUGH HAZARD MITIGATION
BUILDING #4 SIDE ELEVATION - PROPOSED FLOOD MITIGATION
THE BOWERY INN
161 COMMERCE ST. APALACHICOLA, FL

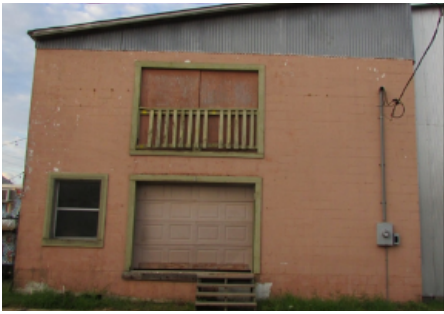
Net Factory Intracoastal Marine Supply

This historic two-story brick warehouse is recommended for dry floodproofing by the mitigation team. The architectural recommendation concurs with dry floodproofing and recommends the installation of aluminum braced flood panels on first floor and the relocation of utilities above flood level.

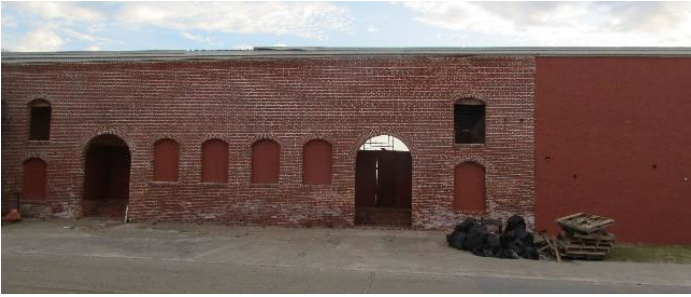
Apalachicola Ice Company

This historic two-story brick warehouse is recommended for wet and dry floodproofing by the mitigation team. The architectural recommendation concurs.

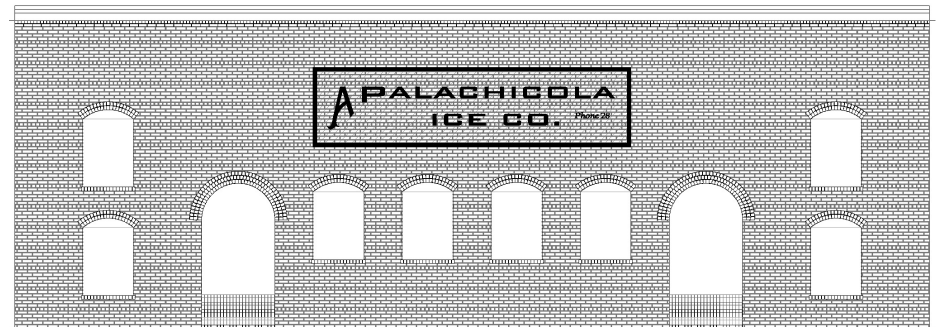
As-Built front elevation

APALACHICOLA FL. ACHIEVING RESILIENCE
THROUGH HAZARD MITIGATION
BUILDING #6 FRONT ELEVATION - AS-BUILT CONDITIONS
THE APALACHICOLA ICE HOUSE
247 WATER ST. APALACHICOLA, FL

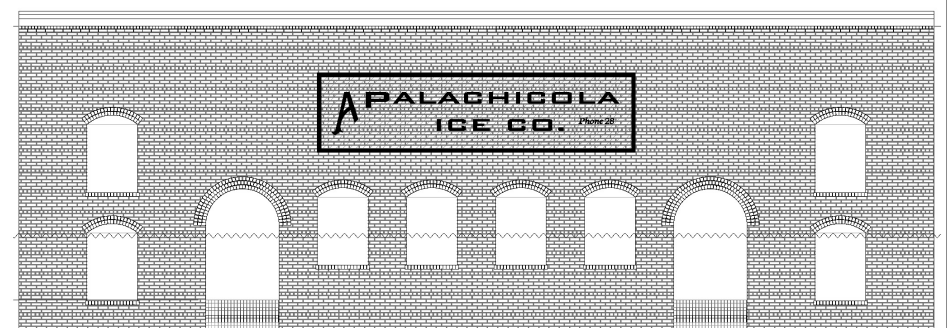
Proposed Floodproofing front elevation

APALACHICOLA FL. ACHIEVING RESILIENCE
THROUGH HAZARD MITIGATION
BUILDING #6 FRONT ELEVATION - PROPOSED FLOOD MITIGATION
THE APALACHICOLA ICE HOUSE
247 WATER ST. APALACHICOLA, FL

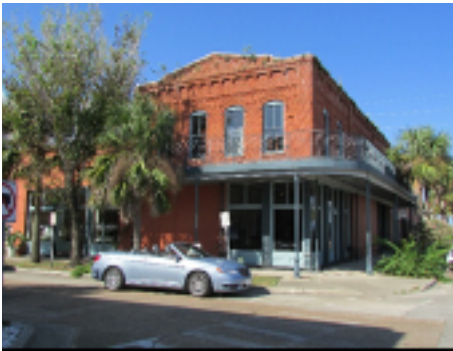
Powers Building

This privately-owned structure is a 150+ year-old brick grade-level warehouse. The mitigation team recommends interior floor elevation for floodproofing. The architectural team recommends implementing measures to make the existing grade-level structure flood resistant. The architectural team recommends the installation of aluminum flood panels over the first floor doors.

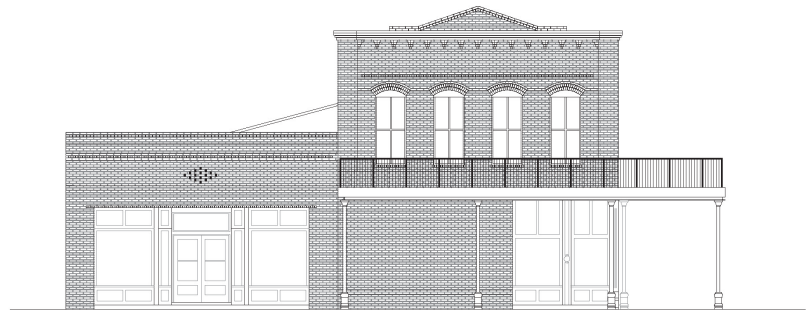
As-Built front elevation

APALACHICOLA FL. ACHIEVING RESILIENCE
THROUGH HAZARD MITIGATION
BUILDING #8 SIDE ELEVATION - AS-BUILT CONDITIONS
POWERS / ZINGERELLI STORE
15 COMMERCE ST. APALACHICOLA, FL

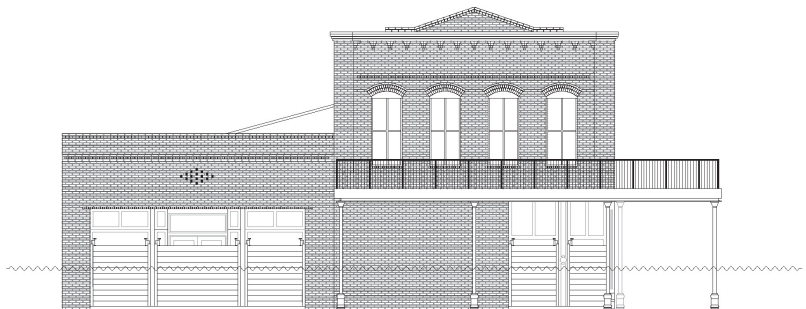
Proposed Floodproofing front elevation

APALACHICOLA FL. ACHIEVING RESILIENCE
THROUGH HAZARD MITIGATION
BUILDING #8 SIDE ELEVATION - PROPOSED FLOOD MITIGATION
POWERS / ZINGERELLI STORE
15 COMMERCE ST. APALACHICOLA, FL
